Observation Report

PROJECT NO. 385687.F1.01

(1) DAY: Tuesday DATE: 6/25/13 WORK PERIOD: 7:45 AM a.m. TO 11:20 PM a.m. REPORT NO. _____
p.m.

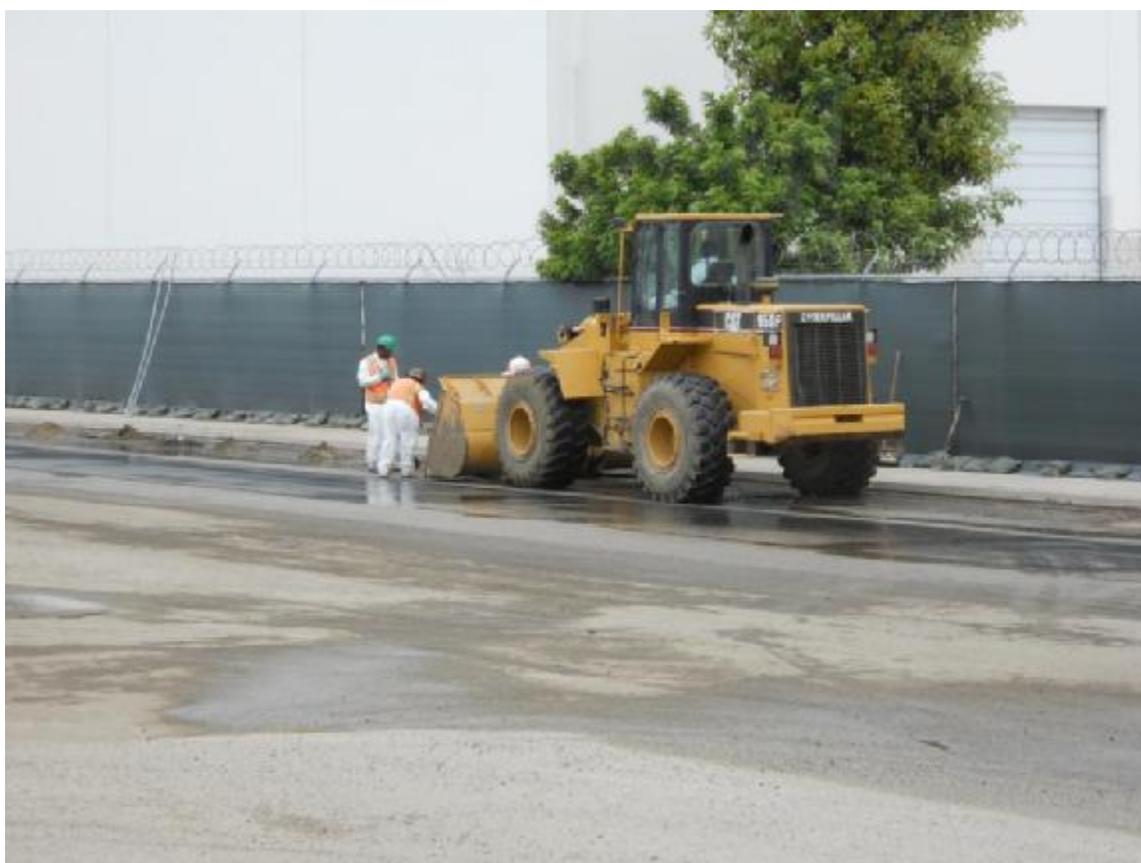
Figure 26: Workers cleaning up along newly installed realigned trench
